The Second Edition of the European NO DIG Conference

Paper 16

REHABILITATION OF AN SUBSEA PIPELINE IN THAILAND

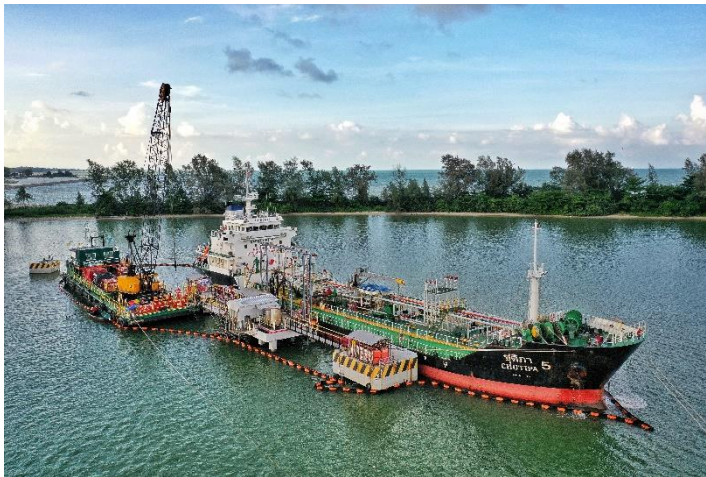
Figure 1. Songkhla offshore platform

The pipeline was originally assigned to the conveyance of fuel oil and extends over a 1000-meter water stretch starting from an offshore platform where the ships deliver oil. Oil is then conveyed through the pipeline to the storage tanks inside a facility on shore.

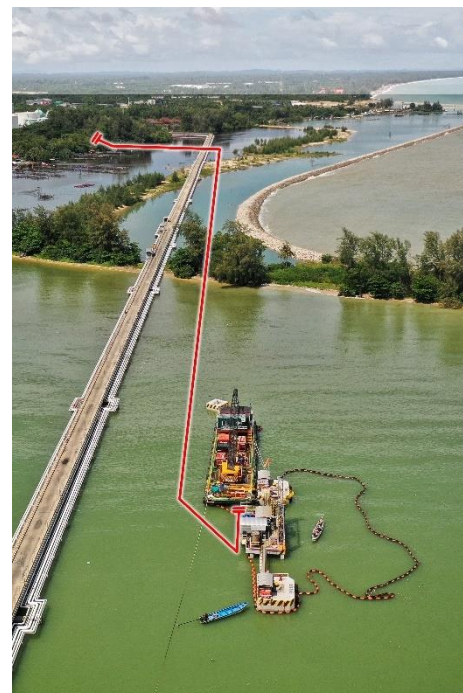
Figure 2. Subsea liner route

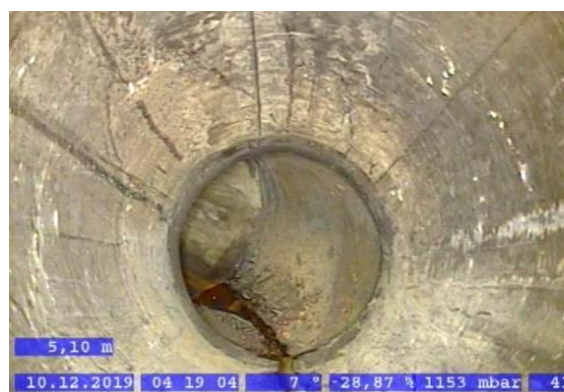
Made of carbon steel, the pipeline is 8 inches (200 mm) wide and turns eight times around 45°. The pipeline had been long out of service since the last inspections detected that loss of integrity was such to impair the necessary safety conditions for oil conveyance. All oil pipelines and pipelines undergo periodic checks to assess their wall thickness by means of ILI pigs, an internal inspection system designed to perform a point detection of any pipe wall thickness and its consistency. In this case, the inspection revealed several areas where the pipeline wall thickness was no longer sufficient to safely withstand the operating conditions at full capacity.

Figure 4. Host pipe 45° bend

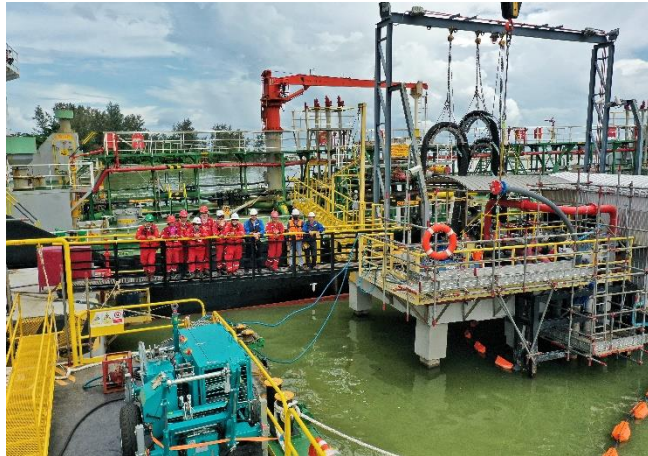
Moreover, a scaffolding was suspended all around the perimeter of the platform to access the pipeline whose end peeks out of the water level rising vertically against the wall of the platform.

Figure 5. Offshore platform

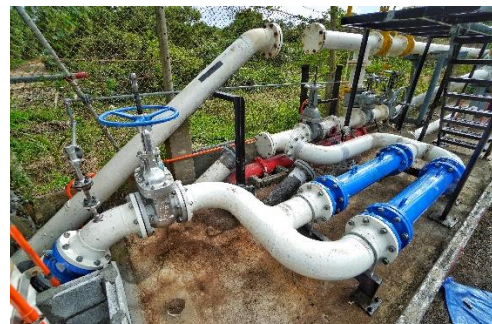
Figure 8. Tie-in during construction

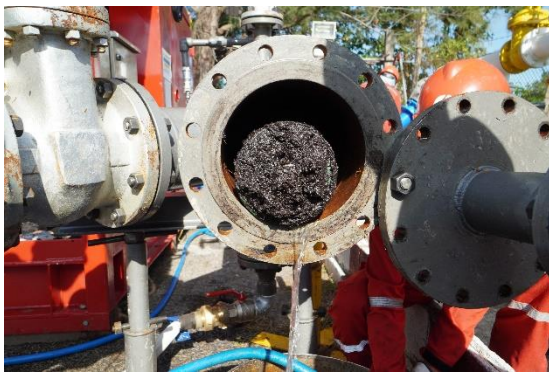
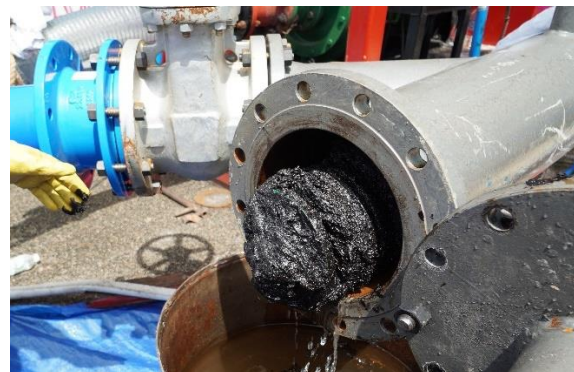
Drainage and clean-up have taken a considerable amount of time and were performed in different steps repeatedly using cleaning pigs of various types. These pigs are pushed inside the pipe by some fluid, nitrogen in this case. Nitrogen is an inert gas that does not react with other chemical compounds. Under this thrust force, the pig travels inside the pipeline and removes all leftovers of the previously conveyed materials leaving behind a perfectly inert pipe.

Figure 9. Cleaning pig at the pig receiver

Figure 10. Cleaning pig at the pig receiver

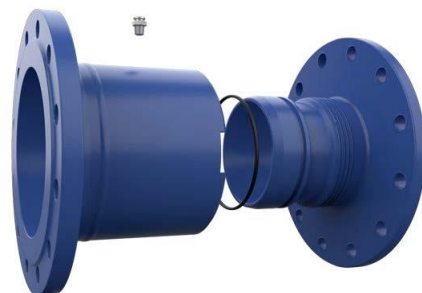
Figure 12. Primus Line Connector based on resin injection

The shown connector consists of a dimensionally stable, profiled connector core and an external sleeve with a deformable metal jacket, as shown in Figure 12. During the installation, a two-component resin injected through

a valve on the external sleeve forces the metal jacket and, consequently, the liner into the contours of the connector core (without coming into direct contact with the liner or fluid). After the resin has cured, the connection is completely tight and permanent.

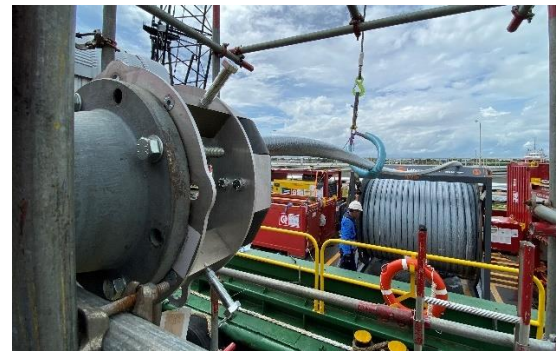
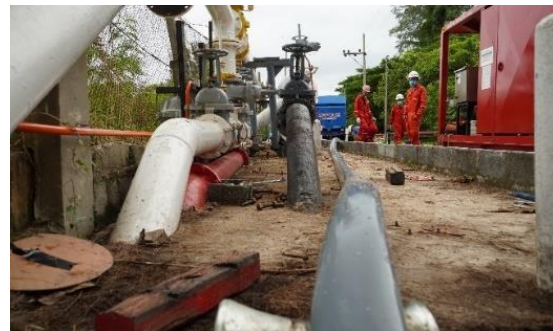
Figure 12. Liner installation phase

Figure 13. Liner installation phase

Figure 15. Liner installation phase

The first step in the rehabilitation was decommissioning the line, which was then separated at the beginning and end of the section to be rehabilitated as seen in Figure 5. This allowed to perform a full CCTV inspection of the section's internal condition and obtain images like those in Figure 6. The next step was cleaning the pipeline by sending a pig through it, according to an evaluation of the previous inspection. The pig's final run was used to establish the necessary cable connection between section ends to pull the liner through the pipeline. Since one of the section end was on water, a barge was used to properly position the transport reel (Figure 7). The folded Primus Liner was then winched into the host pipe, easily navigating all its bends.

After the liner reached the onshore end, it was reverted to its original circular shape using compressed air. The project-specific Primus Line Connectors were then installed, ensuring a tight and tensile connection, guaranteed through a hydrotest. The rehabilitated section was reconnected to the rest of the system, incorporating new pipework between the original structure and the Primus Line Connector (Figure 8). The line could then continue to operate free of corrosion or weak points for at least 20 years more. The new customized pipework included two lined spools called test pieces, which allow for invasive visual and even destructive inspections of the system without disrupting its operation. Depending on the analysis, it is possible to keep the line in function for an even longer period.

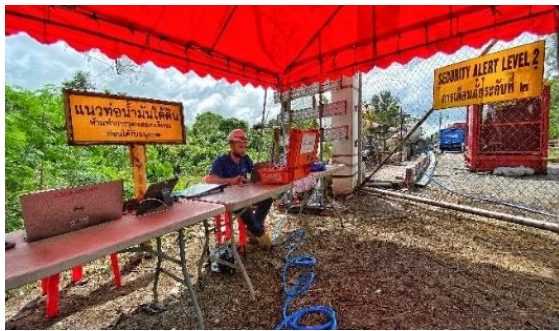
Figure 14. Liner pressure test before commissioning
