Design and operating guidelines for the trenchless rehabilitation of sewer pressure pipelines using lining with inserted hoses

Peter, Lorenz, Int. Account Manager, Raedlinger primus line GmbH

25th May 2023

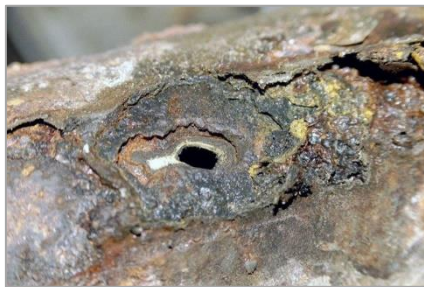
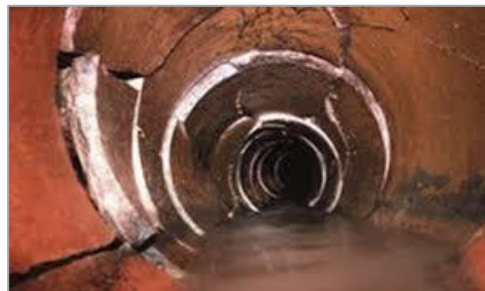
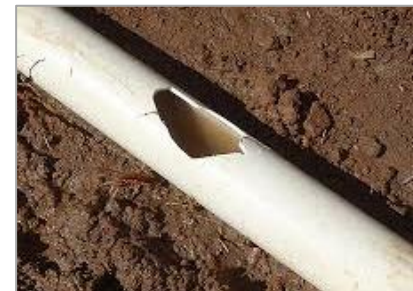
A Typical sewer network with typical failures

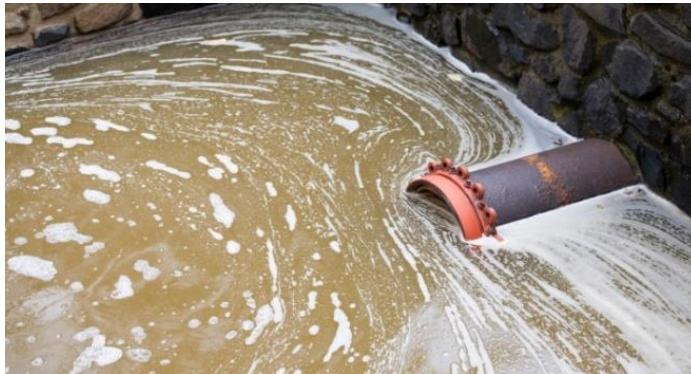
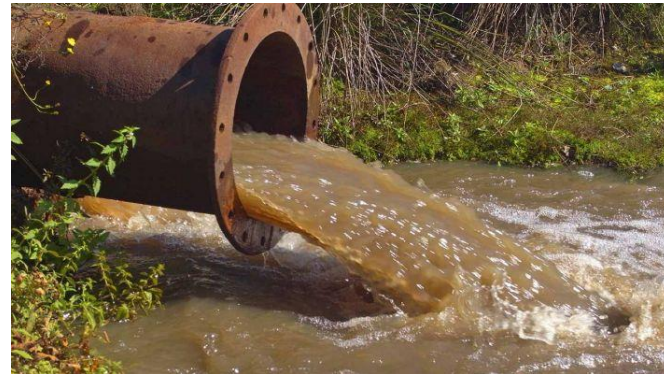
- **No free in- and outlet** for constant flow velocity

- No free in- and outlet for constant flow velocity
- Always filled with transported fluid
 - Non return valve
 - Longitudinal profile
- Installation of pressure release valve for annular space management
- Engineered solutions to modify pipelines to meet the guidelines

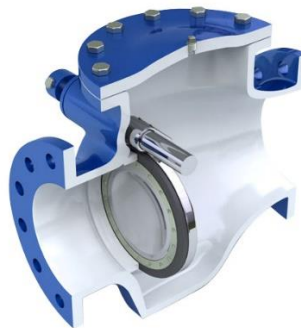
- **Always filled with transported fluid** - Non return valve:

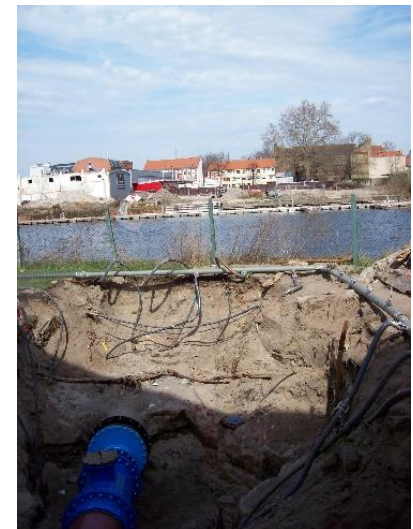
- **Renovation of a 93m long sewer siphon** under the river Havel, Germany (2013)

- DN700 steel pipe with 4 bends of 22.5 degree
- 10 bar operating pressure
- Installation of a DN500 PN17 Primus Liner

- No free in- and outlet for constant flow velocity ✓
- Always filled with transported fluid ✓
- Engineered solutions **Not needed**

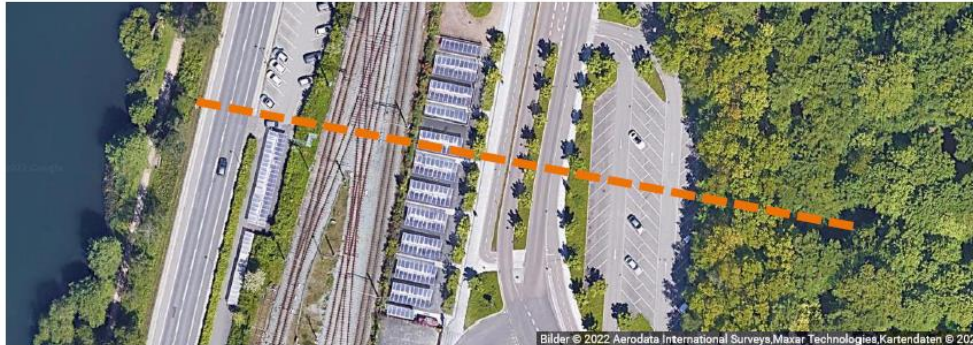
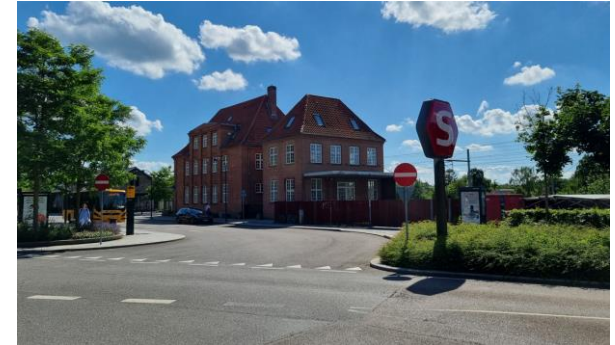
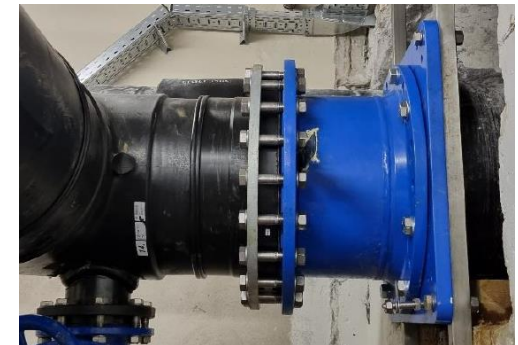
- **Rehabilitation of a 165m long DN500 sewer pressure pipeline** at Holte train station, Denmark

- DN500 PE SDR17 pipeline under a street and several rails as well as a parking lot
- 1.7 – 2.7 bar operating pressure
- Installation of a DN450 PN16 Primus Liner

- No free in- and outlet for constant flow velocity ✓
- Always filled with transported fluid ✓
- Engineered solutions **Not needed**
