The Second Edition of the European NO DIG Conference

Paper 15

ZERO-IMPACT REHABILITATION OF A WATER MAIN IN CONEGLIANO VENETO

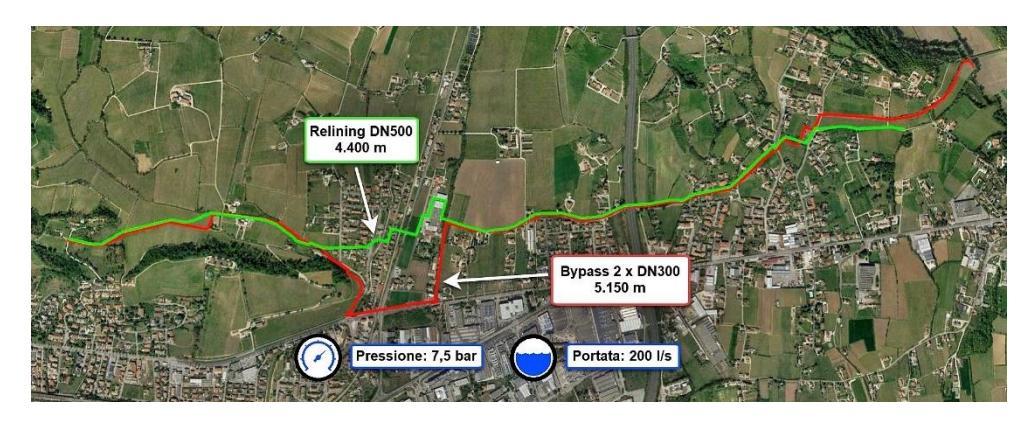
Figure 1. Host pipe and bypass route.

Over the years, Piave Servizi - the Company in charge of the water network in the eastern part of Veneto - has been carrying on an extensive improvement plan for the aqueducts in its territory, undertaking considerable investments. In this framework, Danphix was assigned the rehabilitation of a water main portion serving the town of Conegliano Veneto and seven more municipalities supplying water to some 100,000 users in total. It is a pipe portion stretching over approximately 5 km and made up of asbestos pipes diameter of 500 mm.

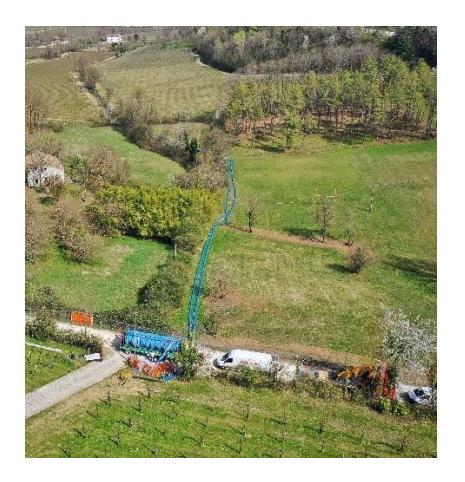
Figure 2. Bypass route.

The design and development of the bypass path and the actual installation of the two interim pipelines was another step of the complex preparation work because no traffic disruption and disturbance to the nearby urban and farming activities were allowed. The pipelines extend across Conegliano's historical center and then stretch out under an open countryside prevalently occupied by numerous vineyards producing Glera grape, a late ripening variety for Prosecco. The bypass was to follow the same route.

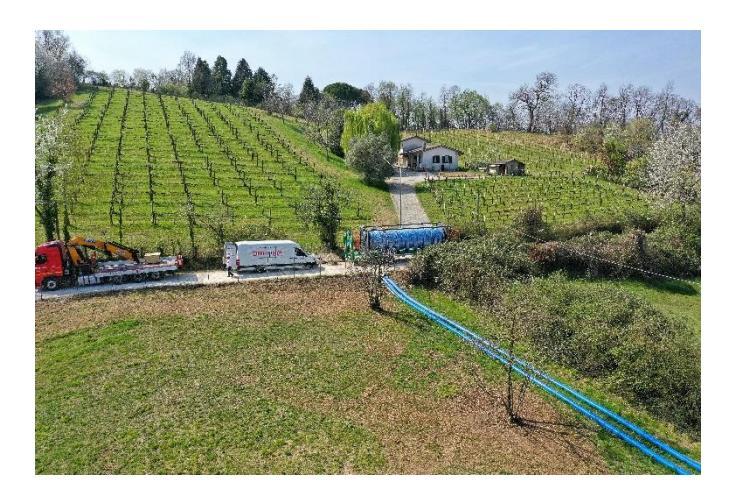
Figure 3. Bypass deployed in the protected area.

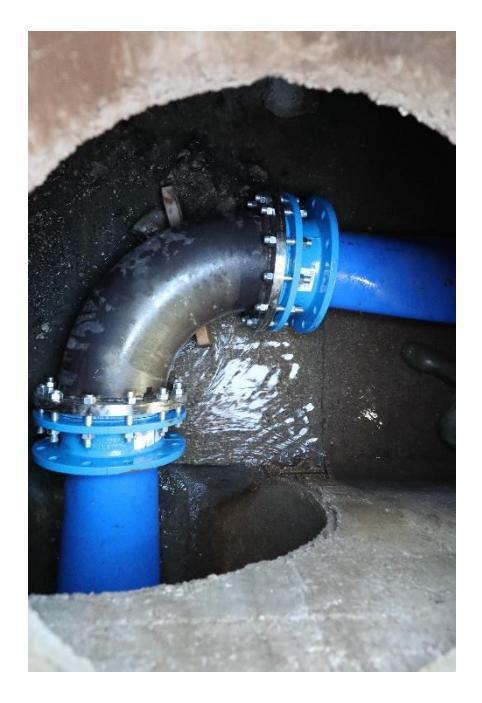
Figure 4. Bypass liner deployed within the storm sewer pipe.

An accurate territory analysis identified the optimal conditions to utilize all the infrastructural facilities already available on site. More specifically, the bypass pipes were buried across all urban sections and all most critical locations like roads and traffic arteries, crossings, and roundabouts. Wherever possible, they have been installed inside the existing sewer lines without compromising the overall hydraulic operation. The pipes were laid on the surface and inside the existing water irrigation channels in the farming areas. In the latter case, the pipes had to be safely anchored, taking all measures to prevent damages due to unforeseeable extreme flow increase in the event of storms and severe weather agents.

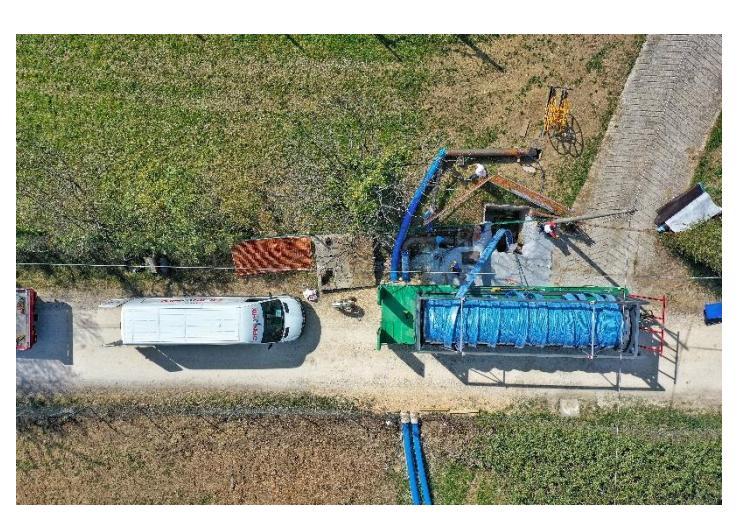
Figure 5. 1.150 m DN500 liner installation phase

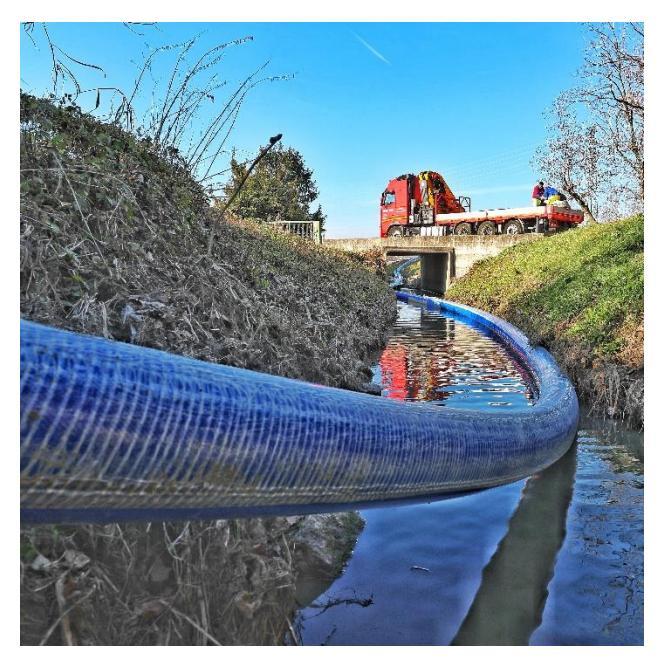
Figure 7. Bypass liner deployed in the water irrigation channel

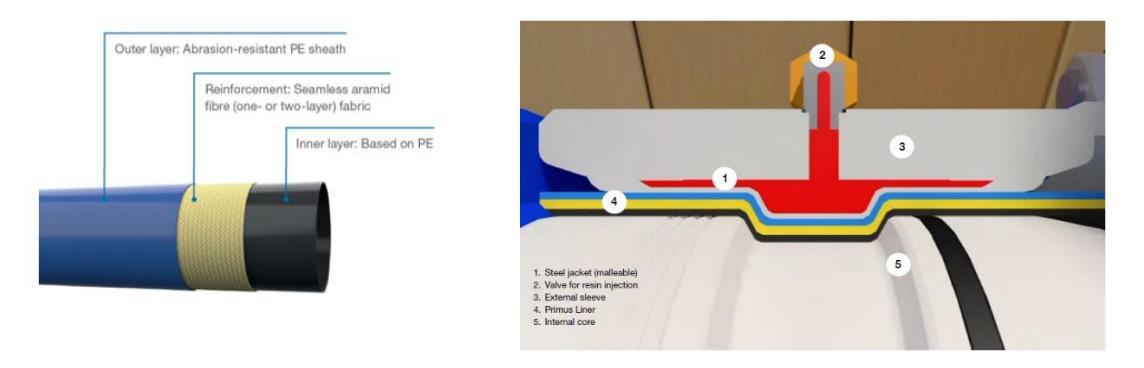
Figure 8. Schematic view of the Primus Liner

Figure 9. Medium and high pressure connector after injection of two-component resin

The bypass installation took about two and a half months of work. Immediately after its completion, a video inspection was done, followed by a pipeline cleaning, all before starting the actual relining operations. Relining was accomplished using the Primus Line system, which Piave Servizi selected based on the crucial and central importance of the old main to be rehabilitated. Primus Line is a lining technique specially designed for the trenchless rehabilitation of pressure pipes of any kind in the broadest range of situations. The most prominent benefit of this system is a remarkable installation time-saving. The Primus Line® system consists of the Kevlar® reinforced liner and specifically developed termination fittings and is available from DN 150 to DN 500. The composite liner consists of three different layers. The inner layer is made of a low-density polyethylene (PE) for potable water applications. The middle layer is made of a mixture of polyester and Kevlar® for low pressure applications available from DN 150 to DN 300 with maximum operating pressures of 25 bar and 12 bar respectively. For higher pressure applications, the middle layer is made of pure Kevlar® and is available from DN 150 to DN 500 vith maximum operating pressures of 56 bar and 16 bar respectively. For special high pressure applications of up to 82 bar for a DN 150 or 32 bar for a DN 400, a second layer of the Kevlar® fabric can be added. The fabric accommodates both the operating pressure as well as the insertion forces during the installation process.

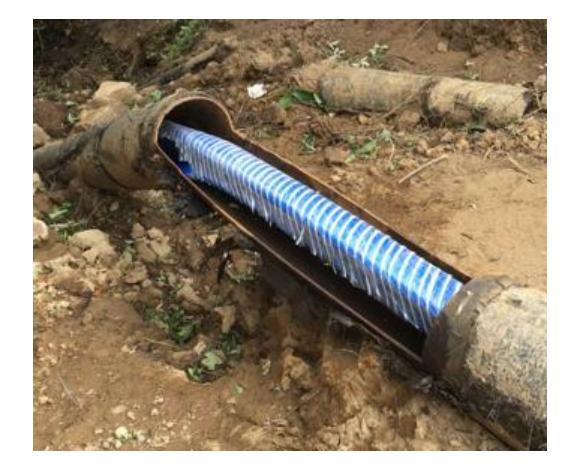
Figure 10. Liner status after pulling and before infalting.

The liner is inserted lose-fit with a pulling winch and does not adhere to the host pipe. Once the liner is in place, compressed air of 0.5 bar is applied to turn the liner into round shape (please refer to figure 11).

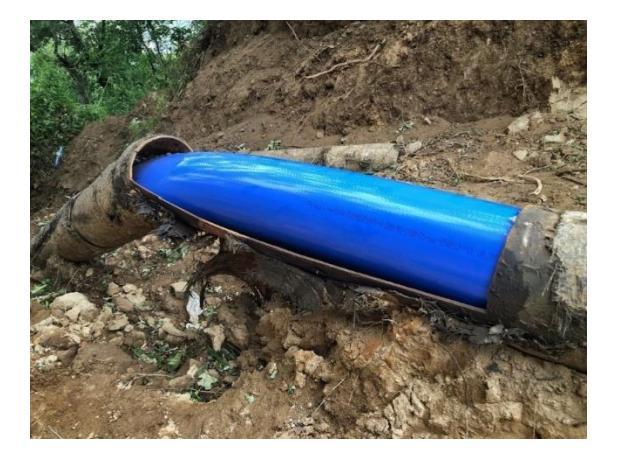
Figure 11. Liner turned into round shape at 0.5 bar

The liner is inserted lose-fit with a pulling winch and does not adhere to the host pipe. Once the liner is in place, compressed air of 0.5 bar is applied to turn the liner into round shape (please refer to figure 11). The liner does not adhere to the host pipe and a small annular space will remain between the liner and the host pipe which does not have to be grouted. Once the liner has been turned into round shape the corresponding termination fittings are installed. After a leak test similar to local standards for HDPE pipes, disinfection, flushing and subsequent connection of the renovated section to the existing water main network, the rehabilitation is completed.

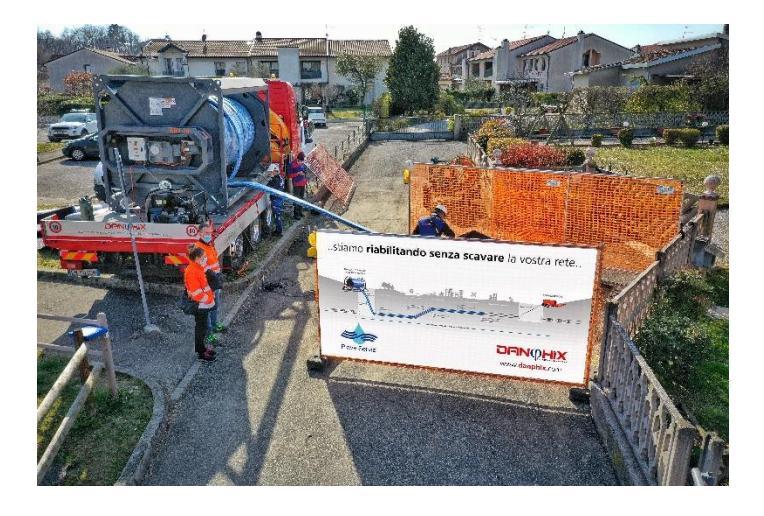
Figure 12. Liner installation phase

The pre-folded liner is sent to the construction site on specific transport reels depending on the required sectional lengths. The liner is folded into U-shape at the factory to reduce the associated pulling forces during the insertion process. Thus, long installation sections can be realized and the stress on the material is minimized. A pulling head is mounted to the start of the liner and connected to a pulling winch. The liner can be installed with installation speeds of up to 400 m per hour.

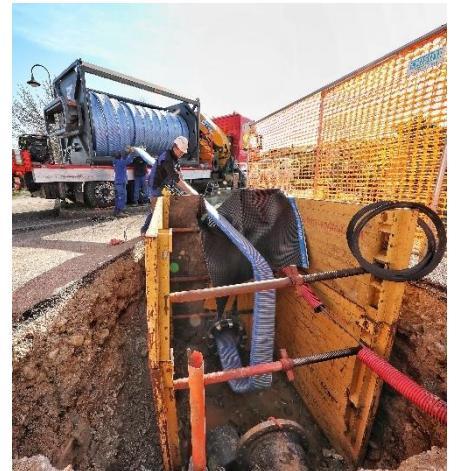
Figure 13. Liner installation phase

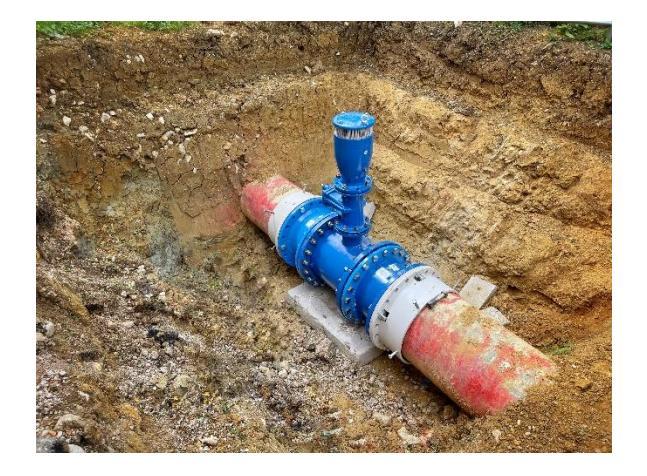
Figure 14. End connectors with an air realise valve spool piece.

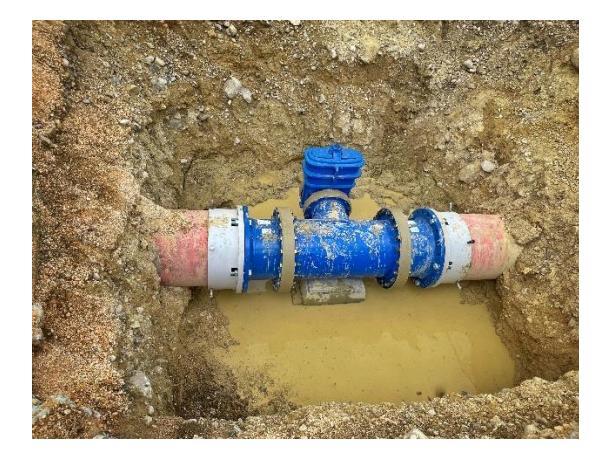
Figure 15. End connectors with a branch connection spool piece.
